Tracing the seismic history of Sant'Agata del Mugello (Italy, Tuscany) through a cross-disciplinary approach

Tracing the seismic history of Sant'Agata del Mugello (Italy, Tuscany) through a cross-disciplinary approach.

Keywords— historical seismicity, historical sources, building stratigraphy, architecture, structural analysis, damage mechanisms, Central Italy

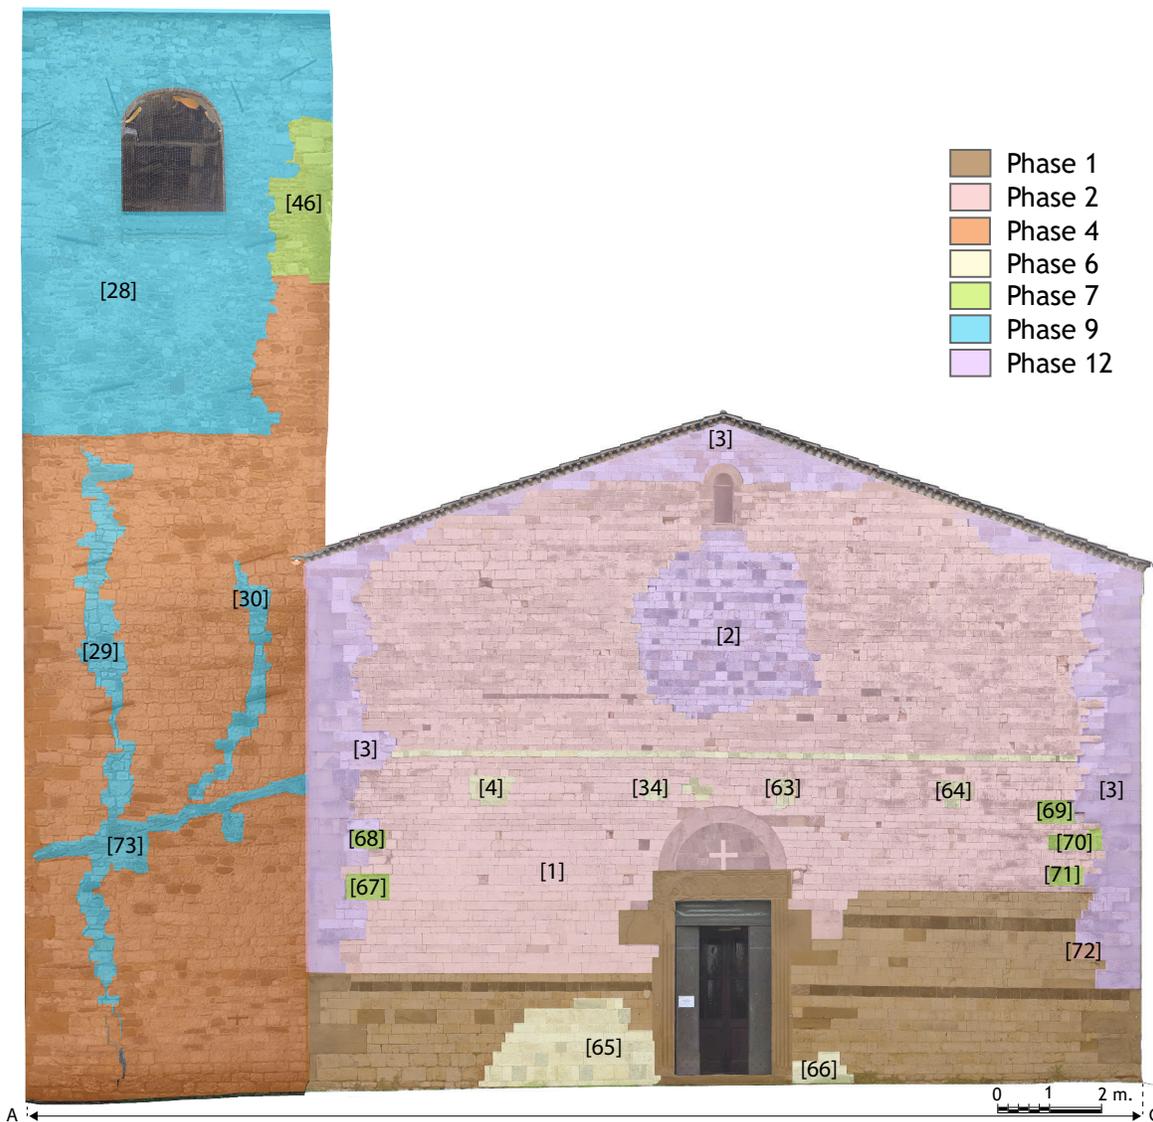
Figure 8: Stratigraphy of the front wall (MR1, external west-facing of the church and MR12, external west-facing of the bell tower) showing phase 1, phase 2, phase 7, phase 8 and phase 13. Phase 1 corresponds to the original construction of the current Romanesque church. Phase 2 is identified as a repair of phase 1.

In the external part, the wall as well as the corners quoins using technique TCM1 are repaired using technique TCM2 (Figure 8). We note the particular case of the south wall corner. The wall corner of phase 1 is repaired using a block of sandstone (in pink in Figure 8) belonging to phase 2. This quoin is nowadays isolated because of a third repair identified as phase 13 described below (phase 13 is associated with a second repair of the corner quoins). In the internal facing (MR1), such a limit is visible on the wall as well as on both pilasters PL3 and PL4 (Figure 9). The use of the technique TCM2 indicates the limit between the first and second constructive phase. Although the limit between phase 1 and phase 2 is mainly reported on the front wall, it is also observed in the external north facing wall of the nave (MR14 shown in Figure 10) at the bottom right. Phase 1 is not visible on the north wall inside the church (Figure 11) not only because the ground is higher but also because this part of the wall has not been repaired. This is an indication of the typology of masonry using the "sacco" technique (this technique corresponds to the filling between two wall claddings). Inside the church, we note that both columns C1 and C2 use TCM1 in the lower part and TCM2 in the upper part. Reminding that the technique of construction TCM2 is dated from the 13th century (Arrighetti [2017]), we date the second phase of the building between 984 and the 13th century. In the absence of historical data, it is difficult to determine an origin to such a deep reconstruction of the church (anthropogenic origin, fire, natural disaster, ...).

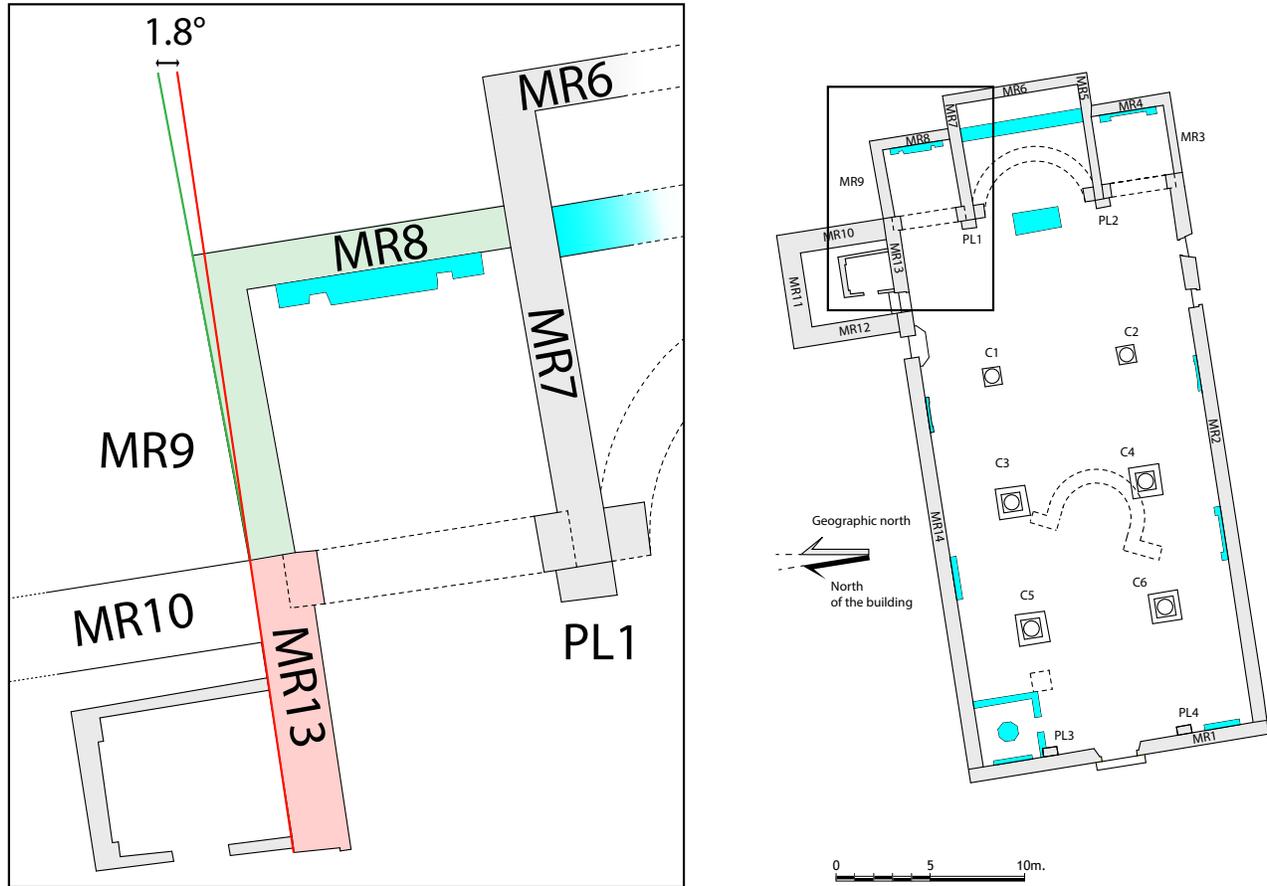
Figure 15: Zoom in the northeast lateral apse. A misalignment is observed between MR9 and MR13.

The delayed construction of both chapels is confirmed by the analysis of the church plan. In Figure 15, we firstly note the angular misalignment of 1.8° between the wall MR9 of the northern chapel and the wall MR13 of the nave (represented in red line and collinear to the central apse walls MR5 and MR7).

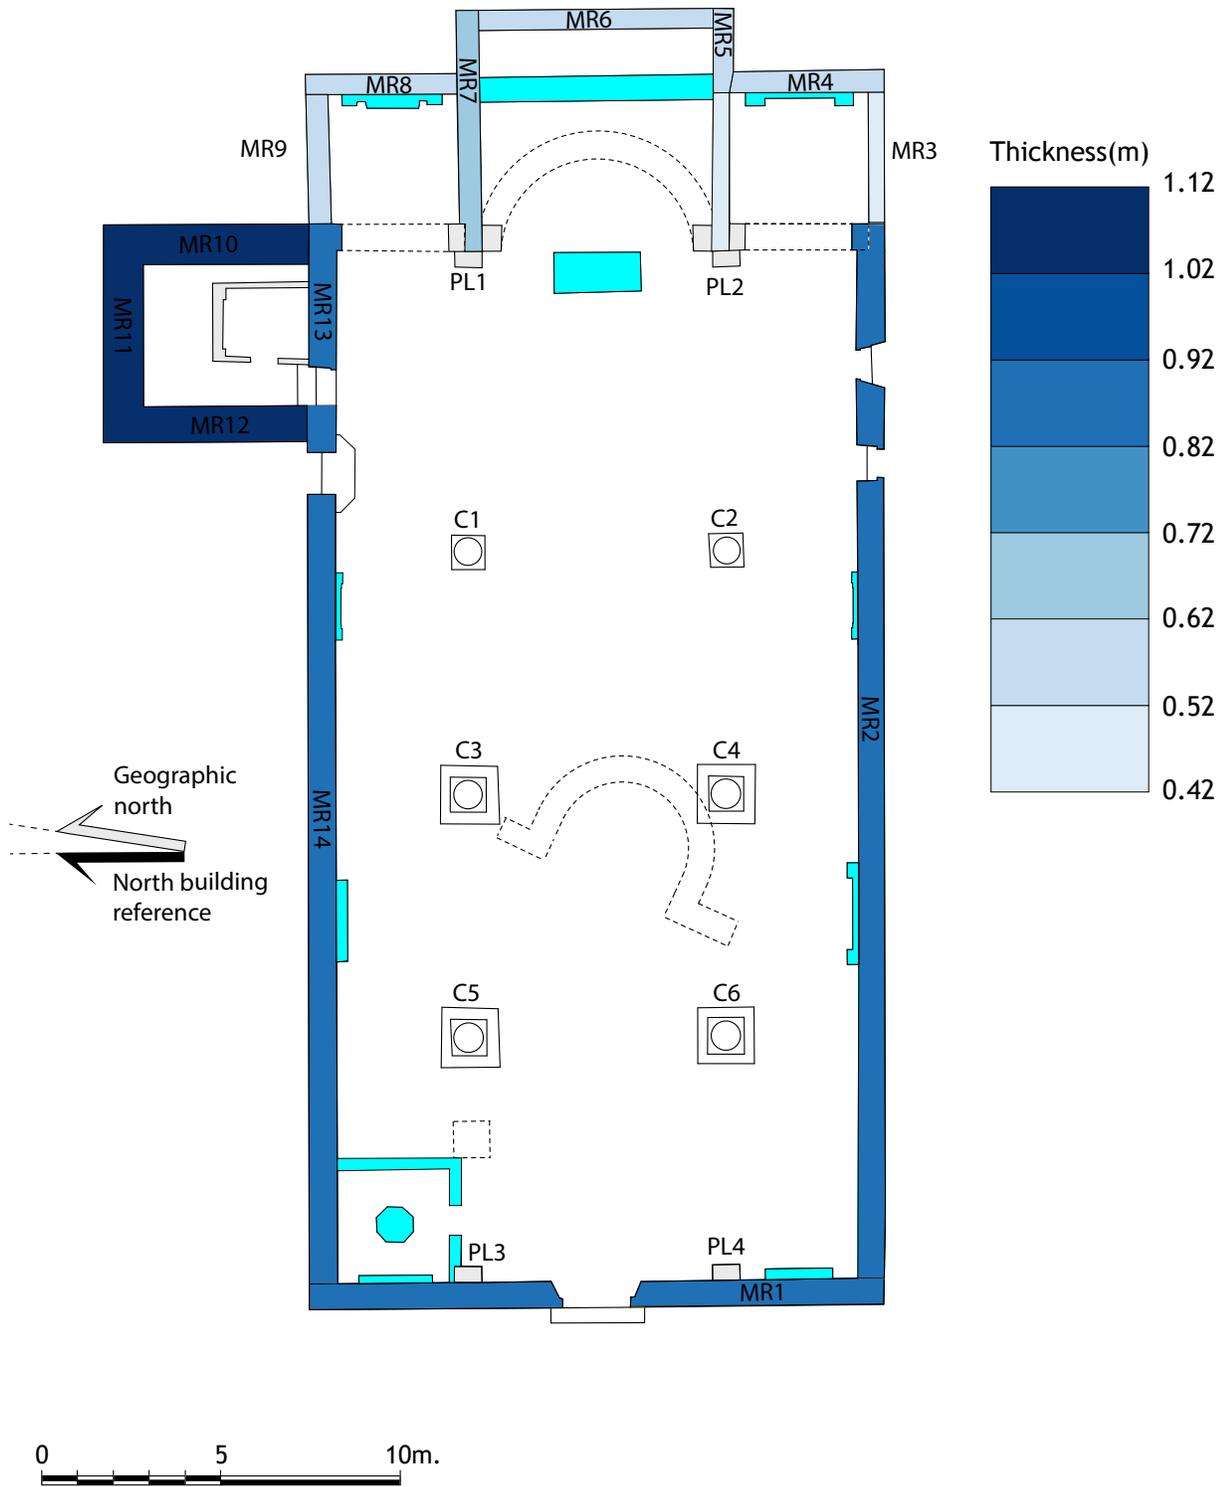
Figure 16: Thickness of the church walls going from 0.42 m to 1.12 m. Such a difference characterizes the building evolution of the church over time.

The thickness of both walls at the bottom is different as shown in Figure 16 (77 cm for MR13 and 61 cm for MR9).

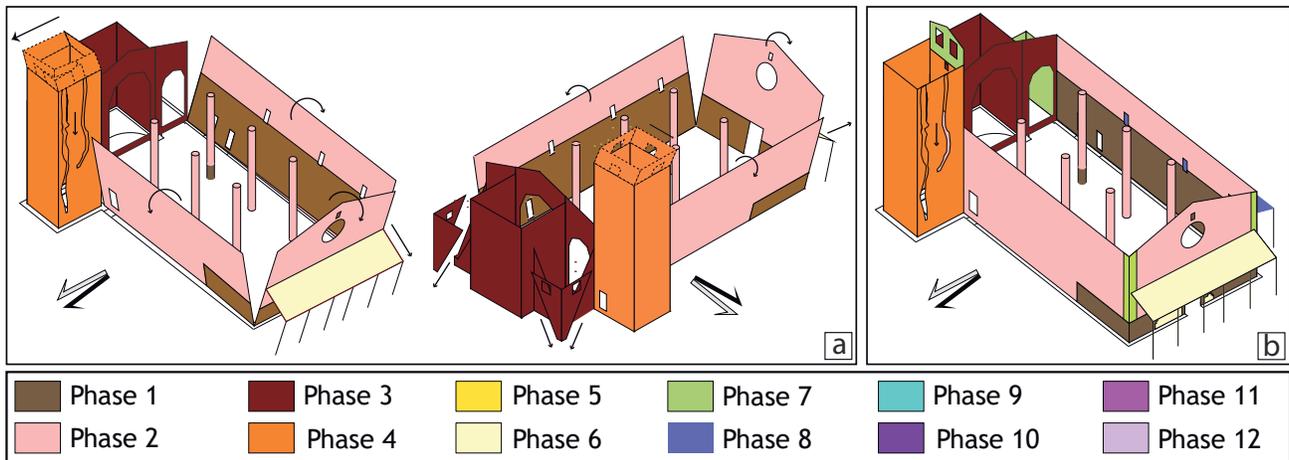
Figure 25: Sketches of the damage mechanisms identified for both, the 1542 (a) and 1611 (b) seismic event.

Archives as well as stratigraphic data show that the top of the bell tower probably collapsed. The north, east and west facing wall of the bell tower were directly covered with a roof (15,5 m high deduced by the bottom limit of OPUR 44, 45 and 46 which also preserved such a limit from other construction phases) while the south wall is raised up above the roof (19,7 m high deduced from opur 44, 45 and 46). The dimensions of the church after such repairs are deduced from Nozzolini's description since he leveled it off 4,7 m. The nave currently has titling walls. Even if the induced damage of the front wall were repaired again when Nozzolini arrived 66 years after the 1542 earthquake, the repairs of the corner quoins are still visible (in green in Figure 24). It induced a bending of the three walls of the nave (Figure 25a). Such a bending is still visible since the corner walls are vertical while the middle part of the nave is bending. An important repair of the two lateral chapel is detected only by stratigraphic analysis. The failure mechanism deduced from such repair is a collapse of both chapels (Figure 25a on the right). It is important to note

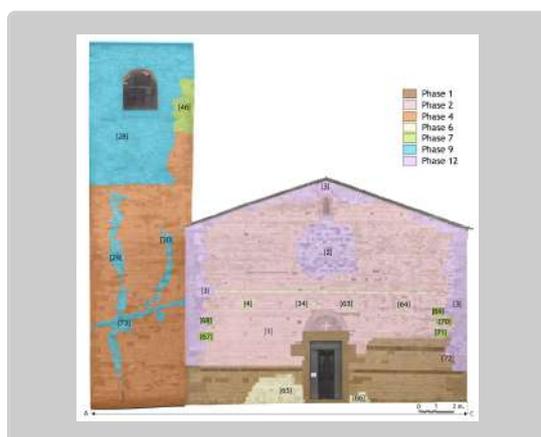
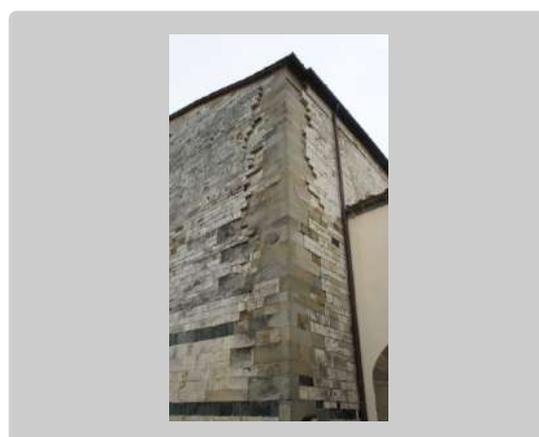
Identity **Intervention partial** - ACoR : TCM2
Repaired part(s) : North, South ; Upper part, Middle part

Hazard **Supposed collapse** (Rocking. Partial overturning of the wall with rotations axis at the floor level)
Ancient origin : undetermined - Probability of the event undetermined

Repair **Reconstruction**
Dimensions (cm) : Length 1500 (preserved), Width 1510, Height 1191
Masonry : Stone, Mortar [Lime and sand]

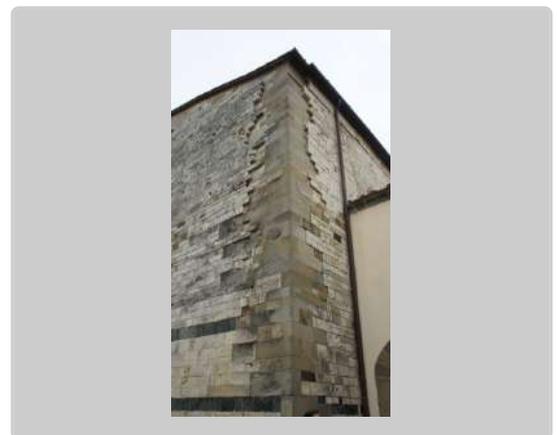
Hazard **Deformation** (Corner overturning)
Ancient origin : earthquake - Probability of the event strong

Other precisions Repair of the two corner quoins of the front wall (MR1) as well as the upper part of the wall. The repair is particularly visible because of a centimetric shift between opur 6 and opur 1.

Use of decimetric blocks of limestone (until 50 centimeter length).
We associated this repair with a seismic event. First it is a typical repair due to a global overturning of the front wall. Such a damage is secondly described in historical source (Tolomeo Nozzolini's log book).

Repair **Not indicated**
Dimensions (cm) : Width 123, Height 787
Masonry, Block : Stone, Mortar [Lime and sand] [dimension of elements : between 20 and 50 cm]
