Tracing the seismic history of Sant'Agata del Mugello (Italy, Tuscany) through a cross-disciplinary approach

Tracing the seismic history of Sant'Agata del Mugello (Italy, Tuscany) through a cross-disciplinary approach.

Keywords— historical seismicity, historical sources, building stratigraphy, architecture, structural analysis, damage mechanisms, Central Italy

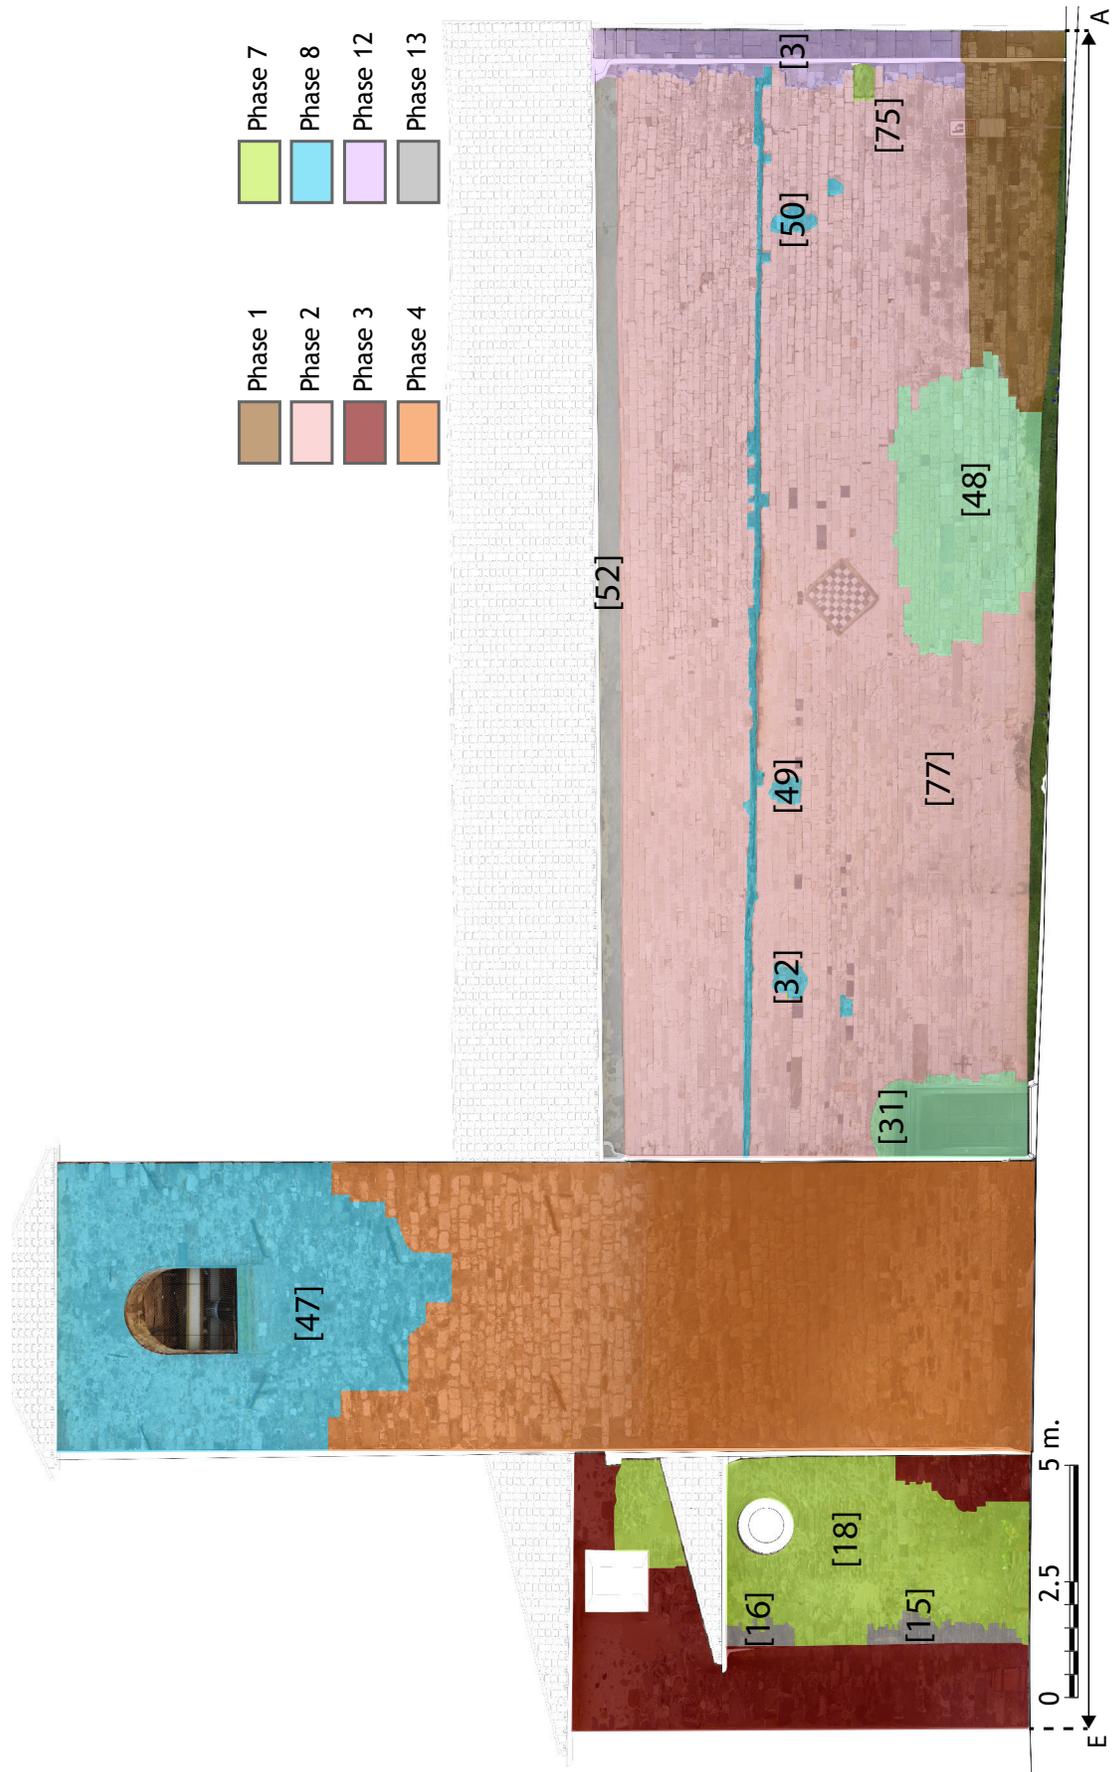
Figure 10: Stratigraphy of the external north-facing of the church (MR14) including the nave (on the right), the bell tower (on the middle) and the north lateral chapel. Phase 1, phase 2, phase 3, phase 4, phase 7, phase 8, phase 12, and phase 13 are identified.

In the case of the two lateral chapels, there is no documentation regarding the 1542 seismic event. A discordance is yet observed between technique TCM10 and technique TCM16 (Figure 10 and 14). In Figure 17, TCM10 is clearly used after TCM16. Such a discordance is interpreted as a repair of the technique TCM16 using technique TCM10. The stratigraphic analysis clearly show that damage description from historical sources should be carefully taken into account. The full collapse of the church described in the texts is not compatible since we still observe the aforementioned phases (phase 1 to phase 6) identified in the nave (Figures 8-13), the lower part of the bell tower (Figure 8) as well as the apse (Figure 14). From historical texts, we only validate the partial destruction of the bell tower (since the lower part which is older is still visible).

The three walls of the bell tower (north wall, west wall and east wall) are leveled off about 4.7 m and then rebuilt at the same height as it is visible today (in blue in Figures 8, 10 and 14). The raising of the roof of the south facing wall of the bell tower (going from a triangular facade to a rectangular one) is visible in green in Figure 12.

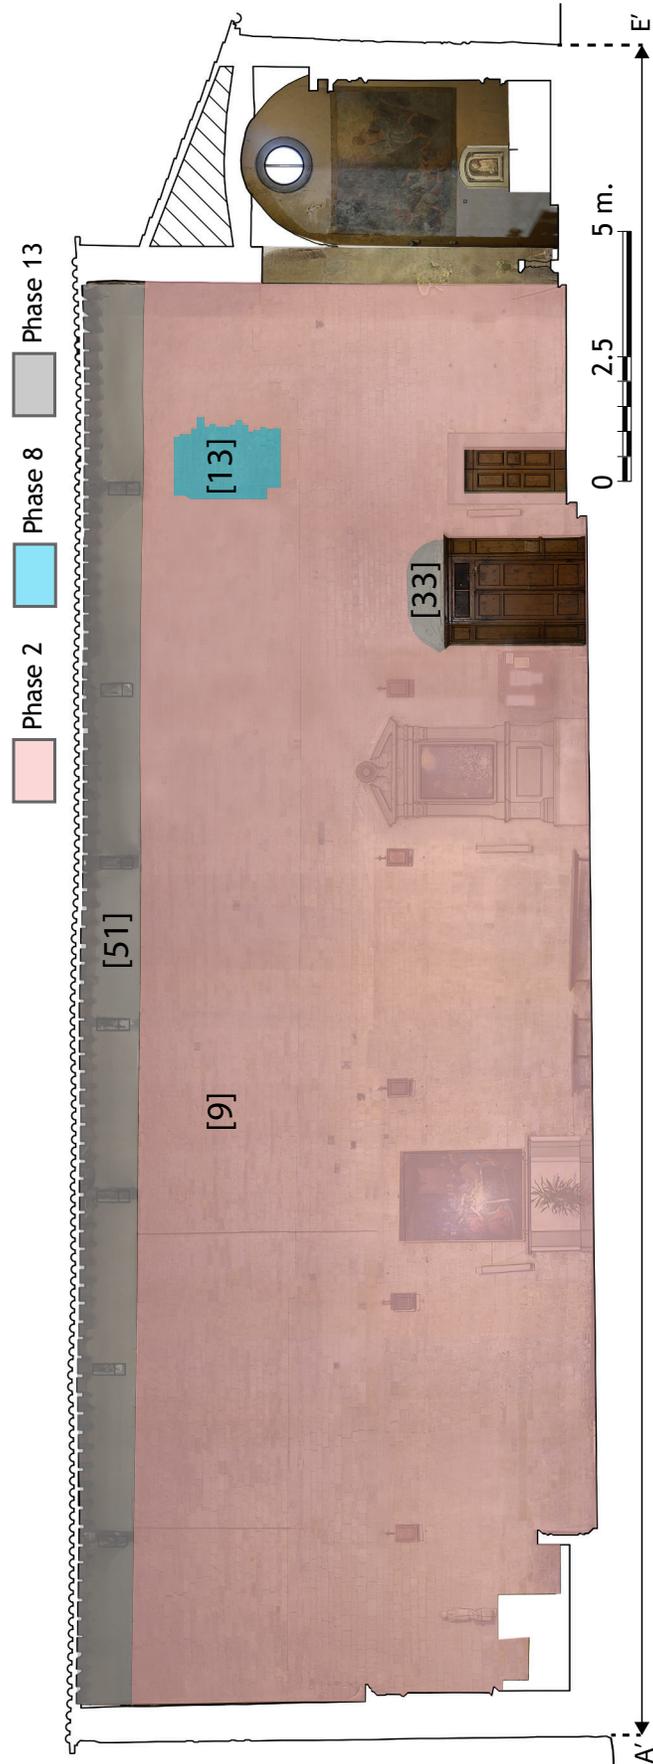
Figure 11: Stratigraphy of the internal north-facing of the church (MR14) including the nave (on the right), the bell tower (on the middle) and the north lateral chapel. Phase 2, phase 4, phase 7, phase 8, and phase 13 are identified.

Nozzolini indeed describes the presence of several items that are no more in the church. In particular the existence of a stair going from the church to the dovecote (located in the bell tower at that time). He filled the door in the bell tower which is still visible (in blue in Figure 11).

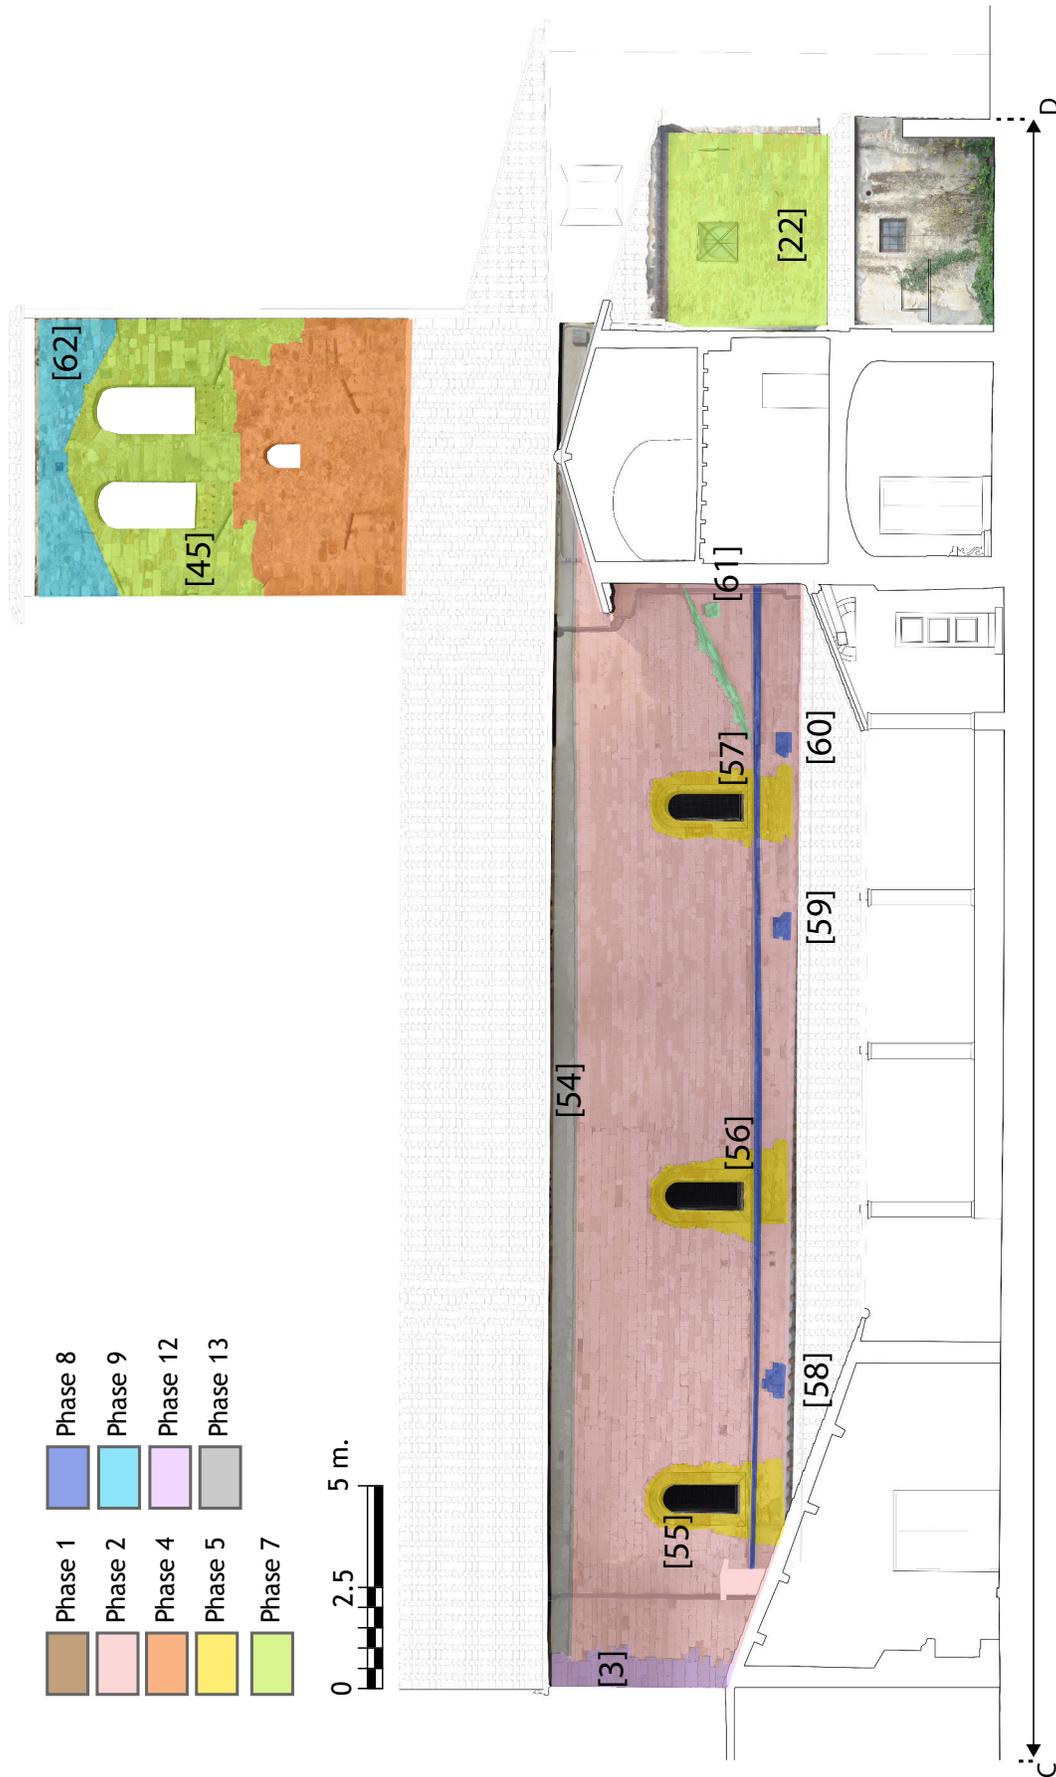
Figure 12: Stratigraphy of the external south-facing of the church (MR2) including the nave (on the left), the bell tower (on the middle) and the south lateral chapel. Phase 2, phase 4, phase 5, phase 7, phase 8, phase 9, phase 12, and phase 13 are identified.

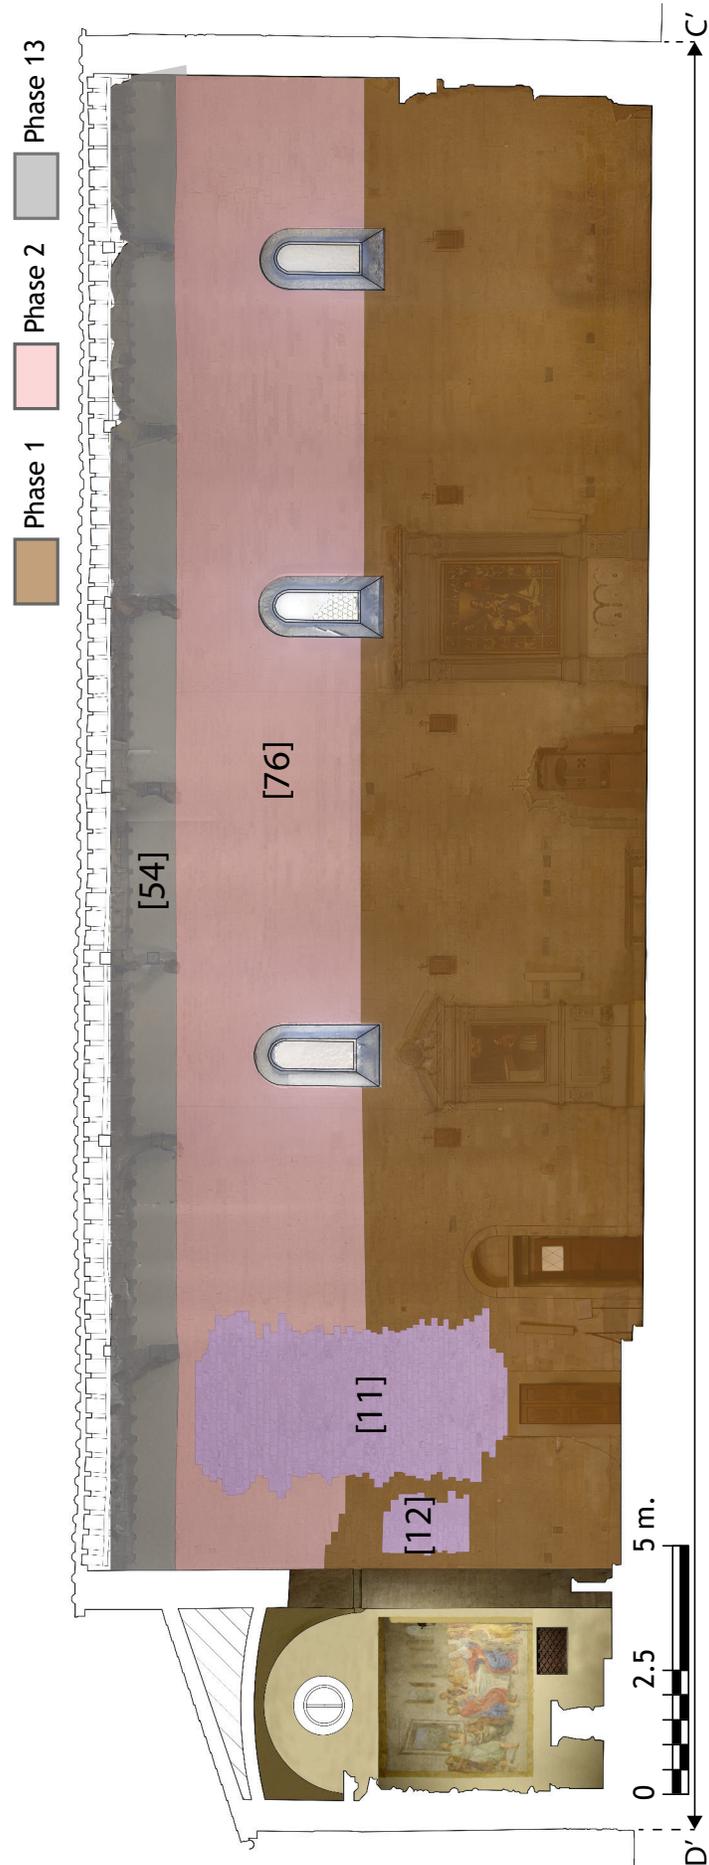
Figure 13: Stratigraphy of the internal south-facing of the church (MR2). Phase 1, phase 2, phase 7 and phase 13 are identified.

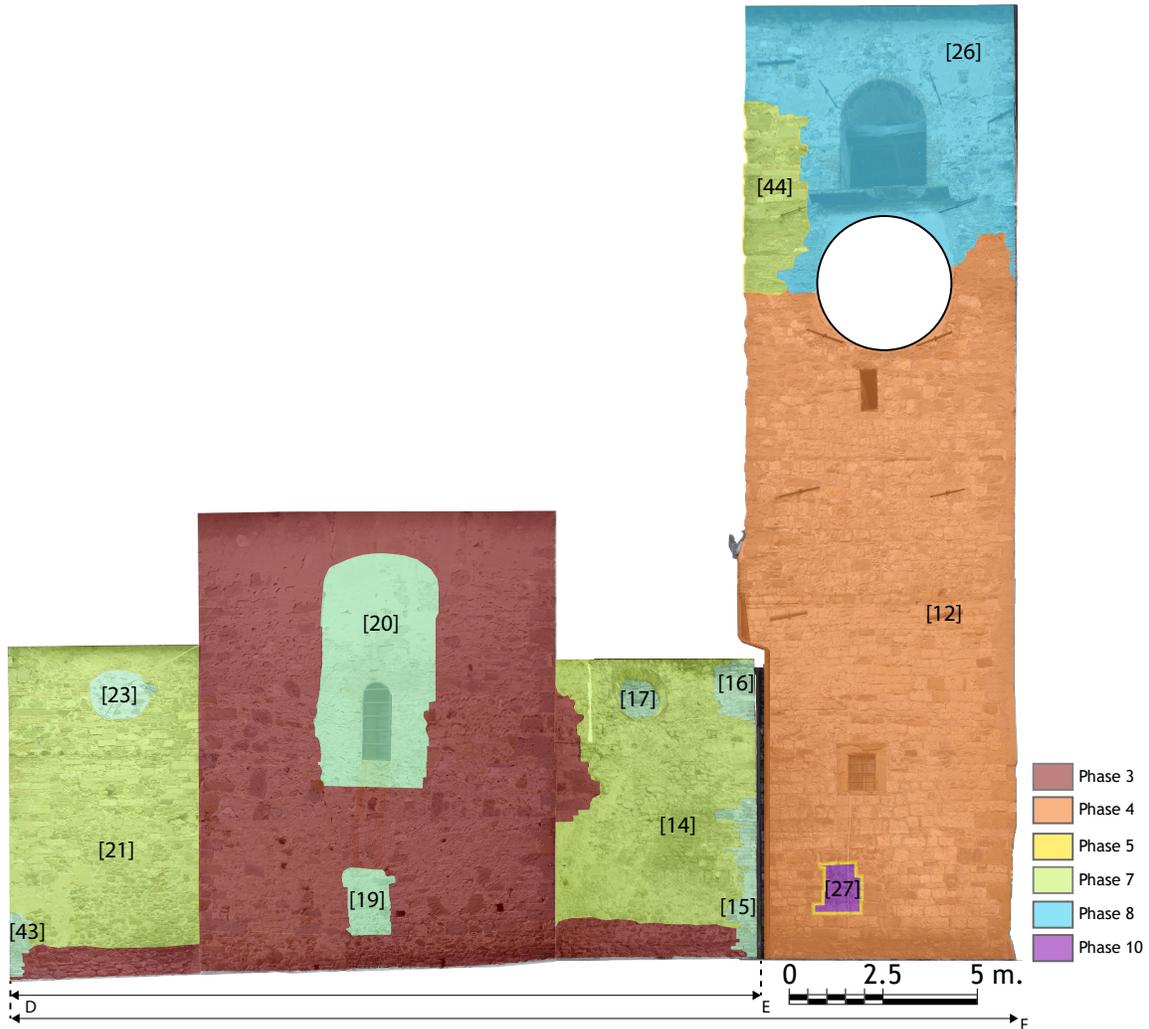
Figure 14: Stratigraphy of the external east-facing of the church (MR4, MR6, MR8) including the bell tower (on the right), the central apse and both lateral chapels. Phase 3, phase 4, phase 5, phase 7, phase 8, and phase 10 are identified.

R. Ajazzi (Ajazzi [1887], p. 15) mentioned two minor renovations of the church. The opening of a door in the east-facing wall of the bell tower in 1497 is retrieved by stratigraphic analysis (Figure 14). The repair of the three windows of the southern wall is also identified (in yellow in Figure 12). R. Ajazzi Ajazzi [1887] mentions the repair of the rose window of the church in 1528 (Ajazzi [1887]). The traces of the old rose window is still visible on both sides of the west wall (MR1) confirming its existence since at least 1542 (Figure 8 and Figure 9). It is nowadays infilled with technique TCM3 (Figure 4).

According to R. Ajazzi [1887] the east door of the bell tower is embedded in 1659. This repair is still visible in Figure 14 (in purple) and corresponds to phase 10.

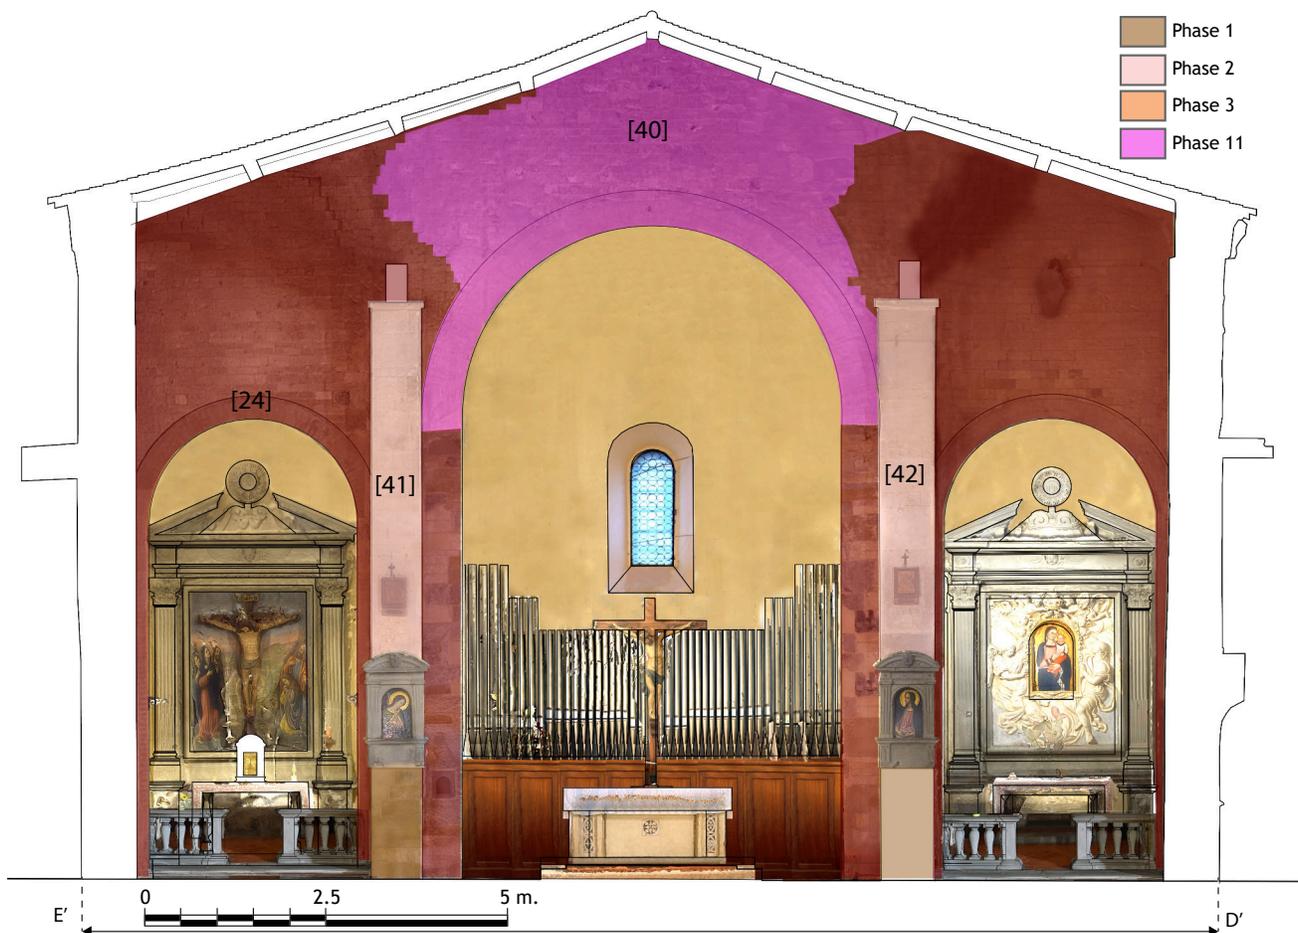
Figure 19: Stratigraphy of the inner east-facing of the church (MR4, MR6, MR8) showing phase 1, phase 2, phase 3 and phase 11. Phase 1 corresponds to the original construction of the Romanesque church. Phase 2 is identified as a repair of phase 1.

In 1819, some restoration works are done in the church choir corresponding to phase 11. The arc of the central apse (ARC2) is raised about 1.20 m (Brunori Cianti [2011]). This operation induced a partial destruction of the upper part of the choir. This restoration work is visible in pink in Figure 19. The two lateral apses are lengthened about 1.8 m (Brunori Cianti [2011]) but this work is no more visible because of the plaster on the walls.

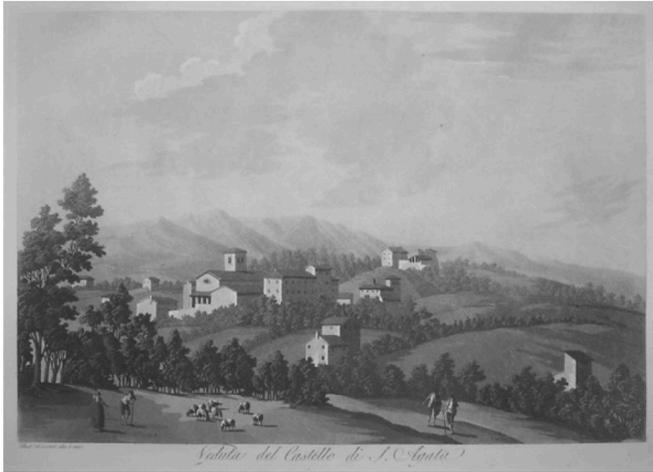
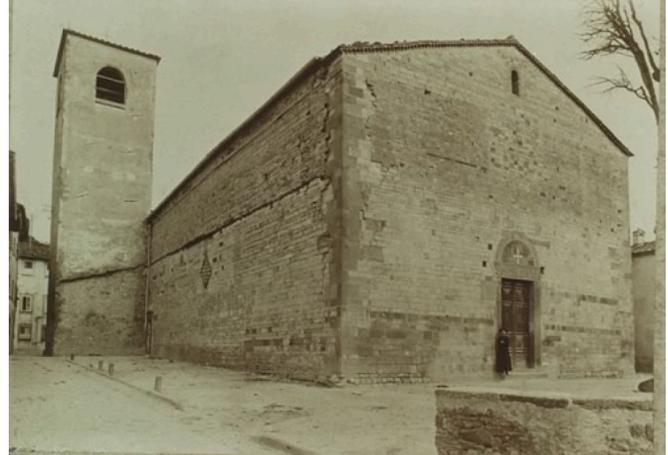
Figure 20: a) View of the church of Sant'Agata in 1802 (Fontani [1802]). b) Photograph of the church in 1905 (personal communication).

The rose window of the church is no more present as shown in Figure 20b contrary to the view shown in Figure 20a. Finally, we note the disappearance of the porch between the picture and the photo.

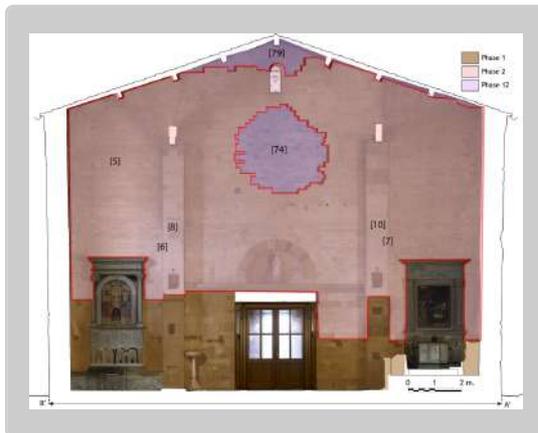
Id. OPUR 5

Hazard **Supposed collapse** (Global overturning of the façade)
Ancient origin : undetermined - Probability of the event undetermined

Repair **Reconstruction**
Dimensions (cm) : Lenght 1500, Height ~7.50, Thickness ?
Masonry, Block : Stone, Mortar [Lime and sand]

Other precisions Front wall of the church (MR1) : internal part of the church.
This is the same description than opur 1 but applied to the inner facing wall of the church.
It is the same repair operation. Type of the masonry : SACO

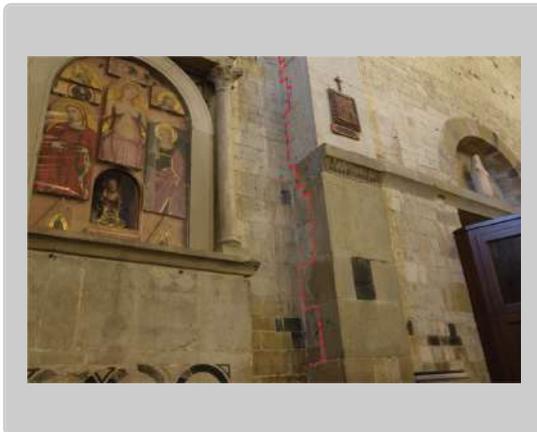
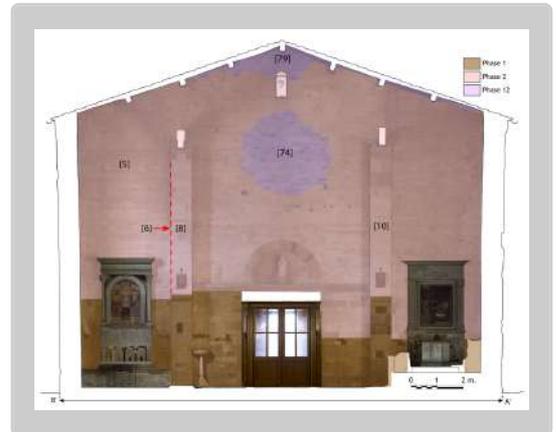
Id. OPUR 6

Hazard **Supposed collapse**
Ancient origin : undetermined - Probability of the event undetermined

Repair **Reconstruction**
Dimensions (cm) : Width 19, Height 231
Masonry : Stone, Mortar [Lime and sand] [dimension of elements : 10 cm]

Other precisions Repair of the south pilaster (PL4) of the inner part of the front wall (MR1). Use of technique TCM2 to repair TCM1. The repair unit is linked to the repair unit of the front wall as described in opur 4. There is only a small part of the repair which is still visible today because this repair is itself repaired by another repair unit.

We note the same repair than the north pilaster (PL3).

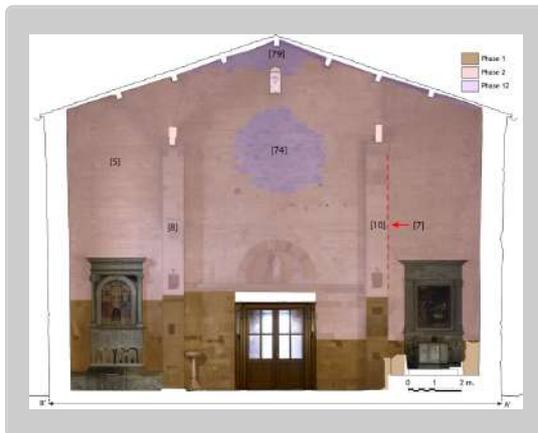
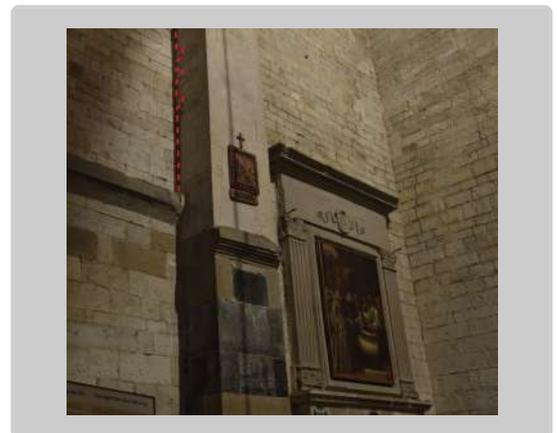
Id. OPUR 7

Hazard **Supposed collapse**
Ancient origin : earthquake - Probability of the event strong

Repair **Reconstruction**
Dimensions (cm) : Width 10, Height 76
Masonry : Stone, Mortar [Lime and sand] [dimension of elements : 10 cm]

Other precisions Repair of the north pilaster (PL3) of the inner part of the front wall (MR1). Use of technique TCM2 to repair TCM1. The repair unit is linked to the repair unit of the front wall as described in opur 4. There is only a small part of the repair which is still visible today because this repair is itself repaired by another repair unit.
Same repair work than the south pilaster (PL4).

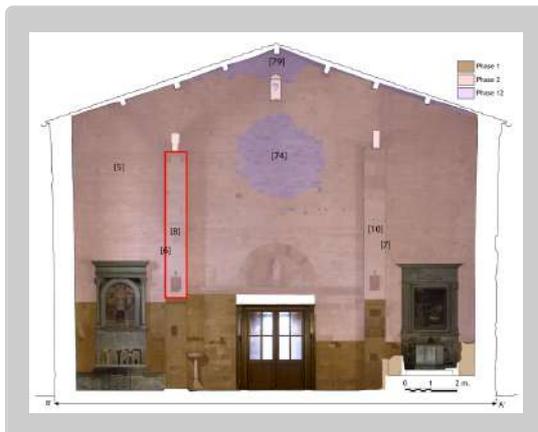
Id. OPUR 8

Hazard **Supposed collapse - Crack**
Ancient origin : undetermined - Probability of the event undetermined

Repair **Not indicated**
Dimensions (cm) : Width 58, Height 483
Masonry, Block : Stone, Mortar [Lime and sand]

Other precisions Reconstruction or damage of the south pilaster (PL4). A crack is visible between the part of the pilaster built against the front wall and the second part that could interpreted as a repair or the consequence of the small overturning of the front wall after the 1542 earthquake. The same technique is used for both part of the pilaster.

Repair or damage?

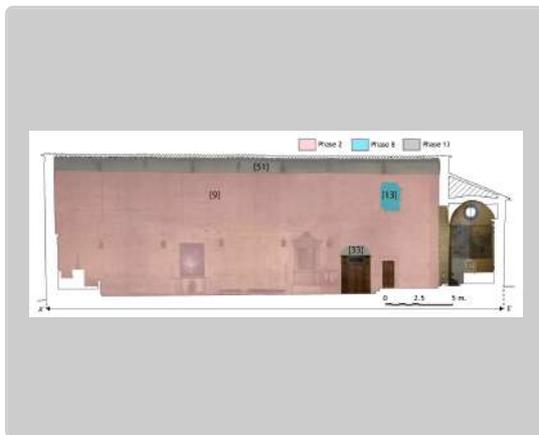
Id. OPUR 9

Hazard **Deformation - Supposed collapse - Crack** (Global complex overturning of the façade)
Ancient origin : earthquake - Probability of the event strong

Repair **Reconstruction**
Dimensions (cm) : Lenght 2842, Height 338
Masonry : Stone, Mortar [Lime and sand]

Other precisions Internal facing wall of MR14 (north wall of the nave).
Reconstruction of the wall from the middle until the top of the wall. Use of TCM2 with blocks of limestone having very fine joints. The repair is visible because the wall is straight ahead contrary to the wall below which undulates slightly.

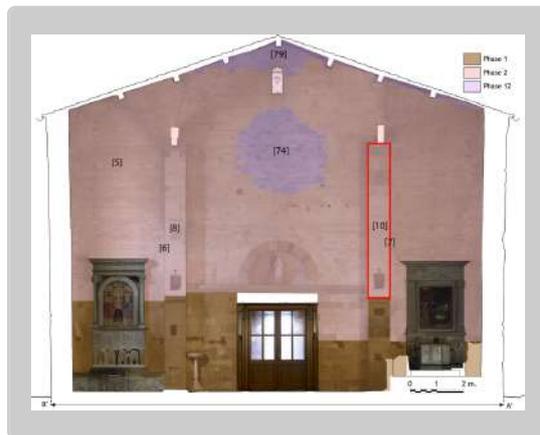
Id. OPUR 10

Hazard **Supposed collapse - Crack**
Ancient origin : undetermined - Probability of the event undetermined

Repair **Not indicated**
Dimensions (cm) : Width 52, Height 490

Other precisions Reconstruction or damage of the north pilaster (PL3). A crack is still visible between the part of the pilaster built against the front wall and the second part that could interpreted as a repair or the consequence of the small overturning of the front wall after the 1542 earthquake. The same technique is used for both part of the pilaster.

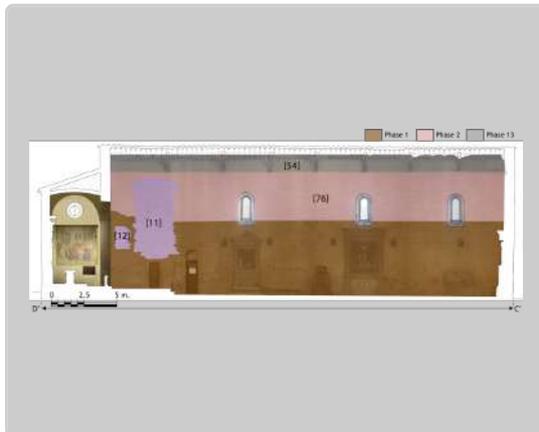
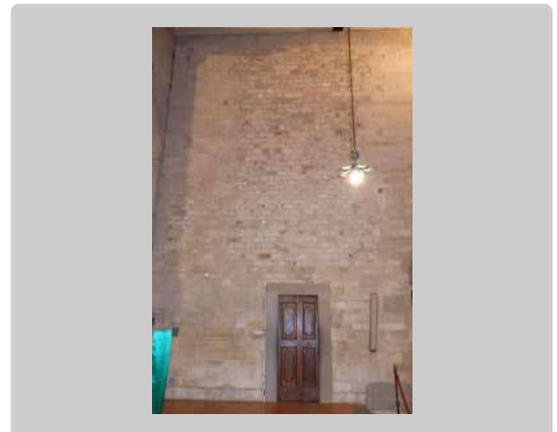
Id. OPUR 11

Hazard **Settling**
Ancient origin : undetermined

Repair **Reconstruction**
Dimensions (cm) : Lenght 720, Height 273
Filling-in, Masonry : Stone, Mortar [Lime and sand]

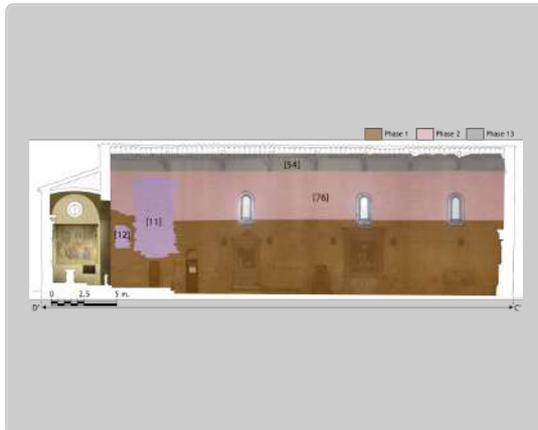
Id. OPUR 12

Hazard **Settling**
Ancient origin : undetermined

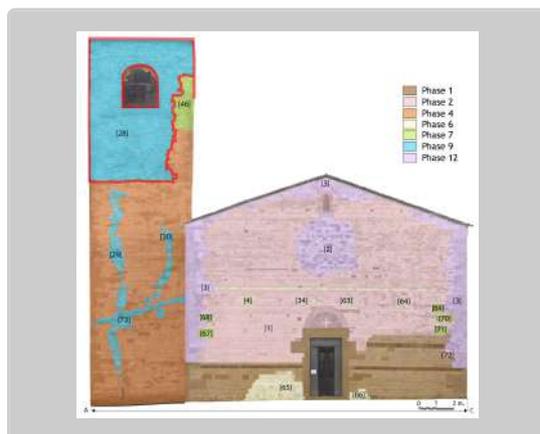
Id. OPUR 29

Localisation SantAgata, , , : Façade wall, load-bearing

Hazard **Fracture** (Vertical crack)
Ancient origin : earthquake - Probability of the event very strong

Other precisions External west facing wall of the bell tower. Infilling of the north crack reinforced using iron chain. TCM13 is used for the repair.

Repair **Cracks filling**
Dimensions (cm) : Width 20, Height 1070
Filling-in : Stone, Terra cotta [Brick], Mortar [Lime and sand]

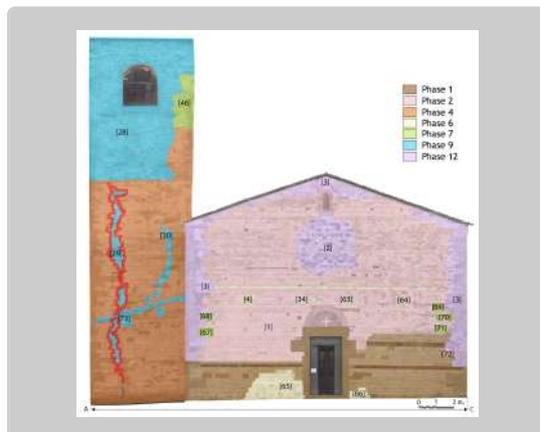
Id. OPUR 30

Localisation Sant'Agata, , , : Façade wall, load-bearing

Hazard **Fracture (Vertical crack)**
Ancient origin : earthquake - Probability of the event very strong

Other precisions External west facing wall of the bell tower. Infilling of the south crack using technique TCM13. Presence of iron chain.

Repair **Cracks filling**
Dimensions (cm) : Width 20, Height 1075
Filling-in : Stone, Terra cotta [Brick], Mortar [Lime and sand]

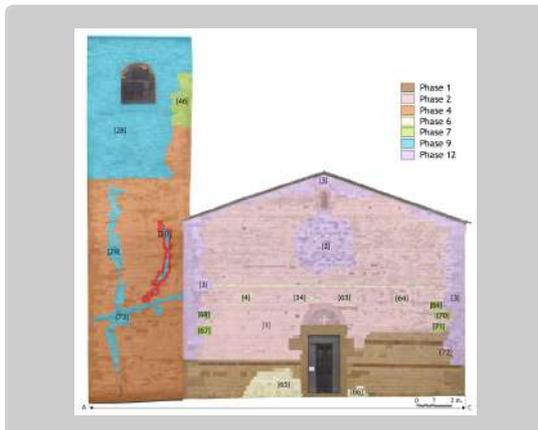
Id. OPUR 31

Localisation SantAgata, , , : Doorway

Hazard **Settling**

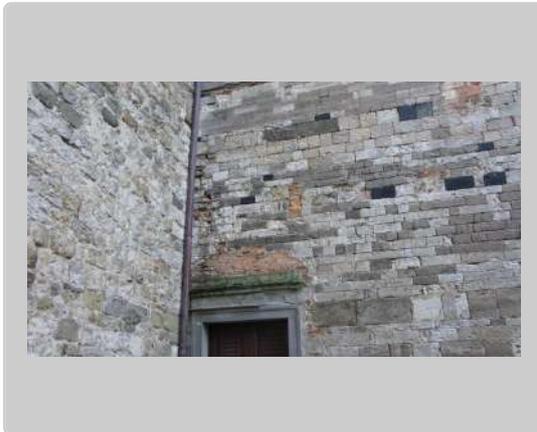
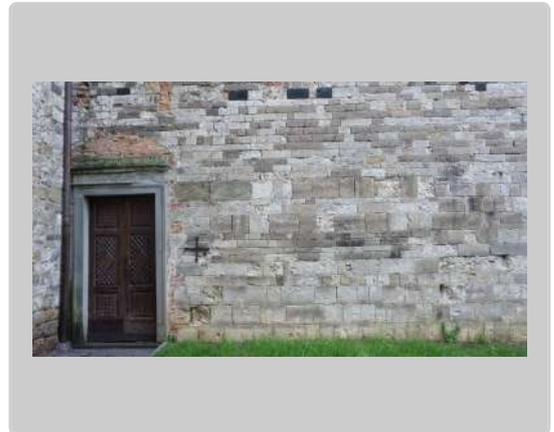
Id. OPUR 32

Localisation SantAgata, , , : Façade wall, load-bearing

Hazard **Supposed collapse**
Ancient origin : undetermined - Probability of the event undetermined

Repair **Reconstruction**
Dimensions (cm) : Lenght 582, Height 273
Filling-in : Stone, Terra cotta [Brick], Mortar [Lime and sand]

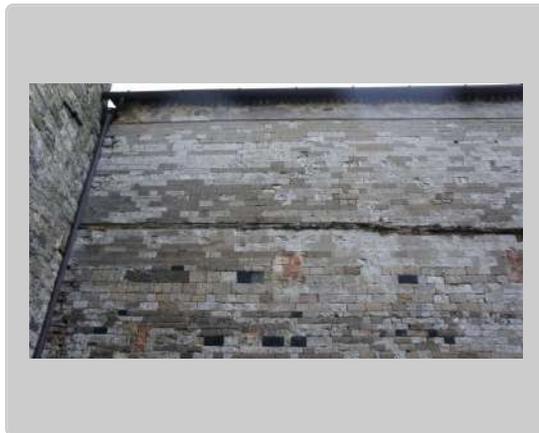
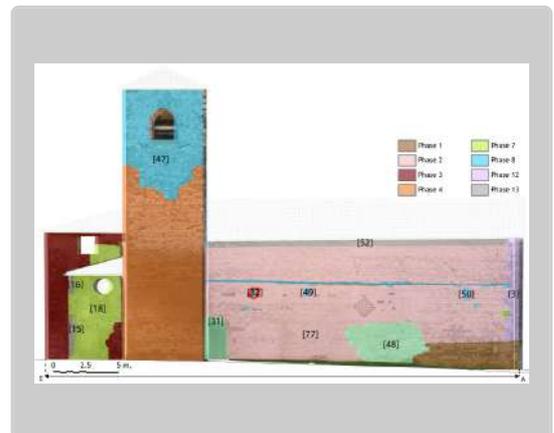
Id. OPUR 33

Localisation SantAgata, , , : Doorway

Hazard **Settling**
Ancient origin : undetermined

Repair **Lintel**
Dimensions (cm) : Lenght 210
Filling-in, Masonry : Stone, Mortar [Lime and sand]

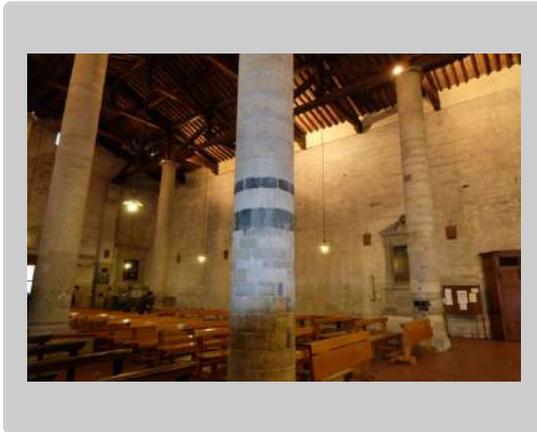
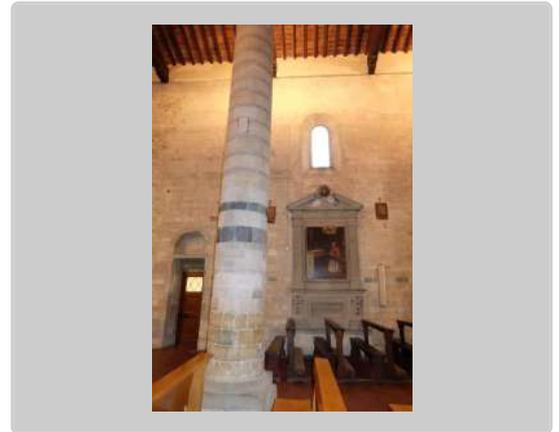
Id. OPUR 36

Localisation SantAgata, , , : Column

Hazard **Supposed collapse - Settling**
Ancient origin : undetermined - Probability of the event undetermined

Repair **Reconstruction**
Dimensions (cm) : Height 402
Masonry : Stone, Mortar [Lime and sand]

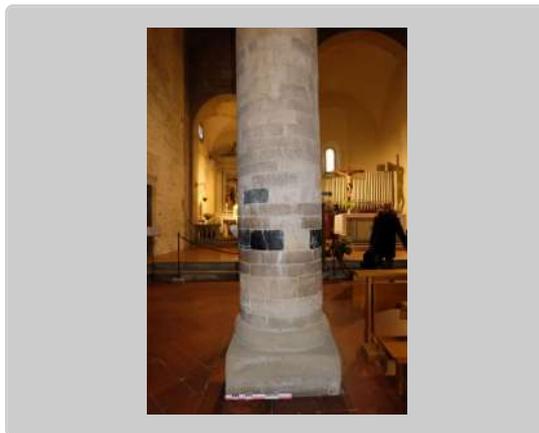
Id. OPUR 37

Localisation SantAgata, , , : Column

Hazard **Supposed collapse - Settling**
Ancient origin : earthquake - Probability of the event strong

Other precisions Column C4. Some blocks from the TCM3 building techniques are replaced with high blocks of sandstone. We did not define a building technique since it is related to modern restorations.

Repair **Reconstruction**
Dimensions (cm) : Height 402
Masonry : Stone, Mortar [Lime and sand]

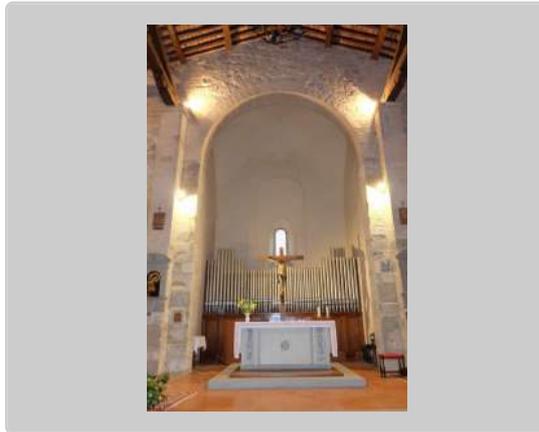
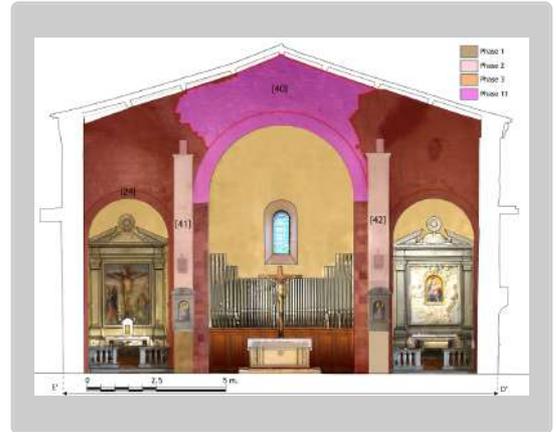
Id. OPUR 41

Localisation SantAgata, , , : Pillar

Hazard **Supposed collapse**
Ancient origin : undetermined - Probability of the event undetermined

Other precisions PL1. North east pilaster. TCM12 repaired the the previous pilaster built with TCM1.
TCM12 is characterized by large blocks of sandstone and limestones (40 cmx20 cm).

Repair **Reconstruction**
Dimensions (cm) : Lenght 40 (maximal), Width 20 (maximal), Height 20 (maximal)

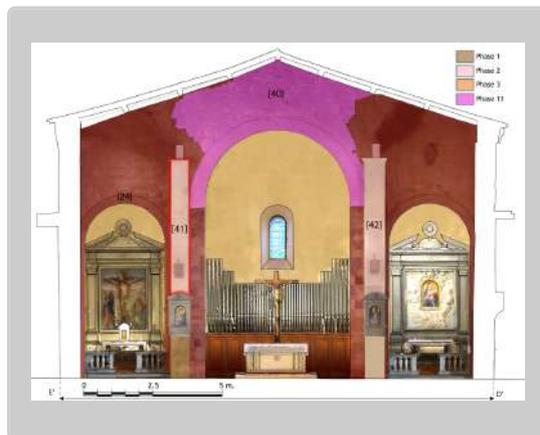
Id. OPUR 42

Localisation SantAgata, , , : Pillar

Hazard **Supposed collapse**
Ancient origin : undetermined - Probability of the event undetermined

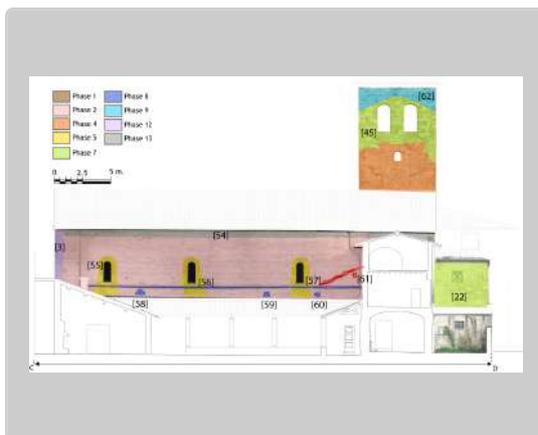
Id. OPUR 62

Localisation Sant'Agata, , , : Façade wall, load-bearing

Identity **Intervention partial** - ACoR : TCM14
Repaired part(s) : North, South ; Upper part

Hazard **Supposed collapse** (Partial overturning of the wall with rotations axis at the floor level)
Ancient origin : earthquake - Probability of the event strong

Repair **Reconstruction**
Dimensions (cm) : Width 563, Height 502
Masonry : Stone, Terra cotta [Brick], Mortar [Lime and sand]

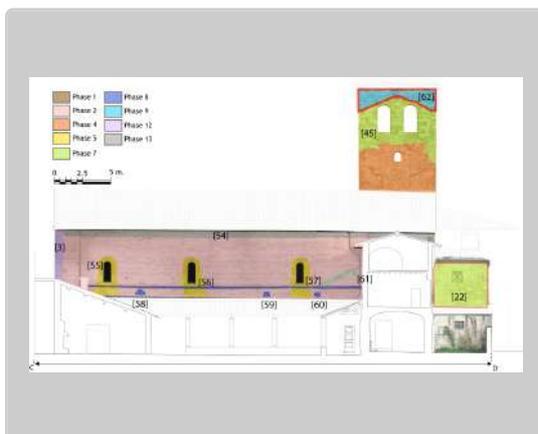
Id. OPUR 63

Localisation SantAgata, , , : Façade wall, load-bearing

Identity **Intervention partial - ACoR** : TCM2
Repaired part(s) : North, South ; Middle part

Hazard **Supposed collapse**
Ancient origin : undetermined - Probability of the event undetermined

Repair **Reconstruction**
Dimensions (cm) : Lenght 50, Height 50, Thickness 75
Masonry, Filling-in : Stone, Mortar [Lime and sand]

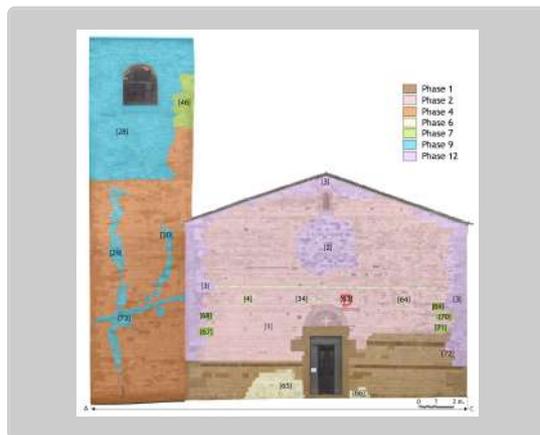
Id. OPUR 64

Localisation SantAgata, , , : Façade wall, load-bearing

Identity **Intervention partial - ACoR** : TCM2
Repaired part(s) : North, South ; Middle part

Hazard **Supposed collapse**
Ancient origin : undetermined - Probability of the event undetermined

Repair **Reconstruction**
Dimensions (cm) : Lenght 50, Height 50, Thickness 75
Masonry, Filling-in : Stone, Mortar [Lime and sand]

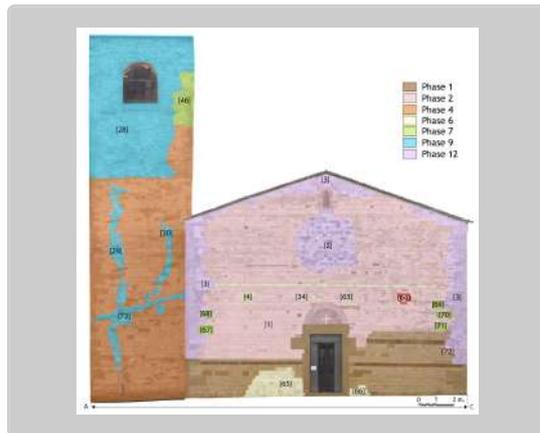
Id. OPUR 65

Localisation SantAgata, , , : Façade wall, load-bearing

Identity **Intervention partial** - ACoR : TCM4
Repaired part(s) : North, South ; Middle part

Hazard **Supposed collapse**
Ancient origin : undetermined - Probability of the event undetermined

Repair **Reconstruction**
Dimensions (cm) : Lenght 50, Height 50, Thickness 75
Masonry, Filling-in : Stone, Mortar [Lime and sand]

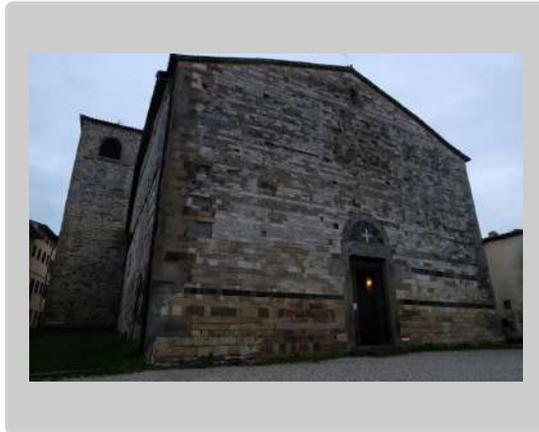
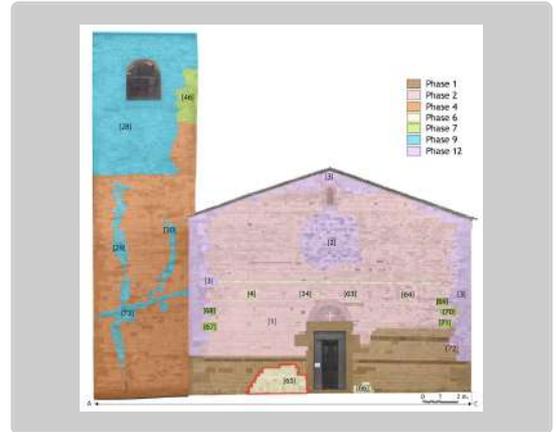
Id. OPUR 66

Localisation SantAgata, , , : Façade wall, load-bearing

Identity **Intervention partial** - ACoR : TCM4
Repaired part(s) : North, South ; Middle part

Hazard **Supposed collapse**
Ancient origin : undetermined - Probability of the event undetermined

Repair **Reconstruction**
Dimensions (cm) : Lenght 50, Height 50, Thickness 75
Masonry, Filling-in : Stone, Mortar [Lime and sand]

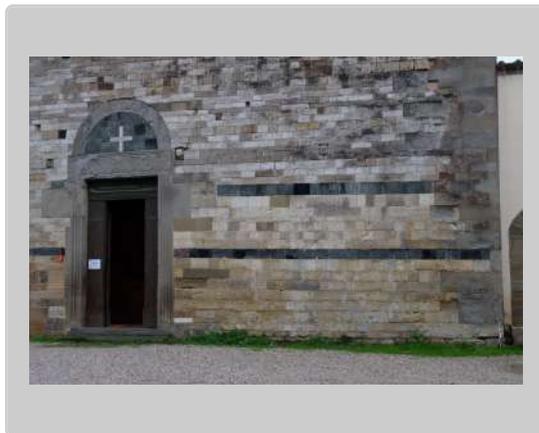
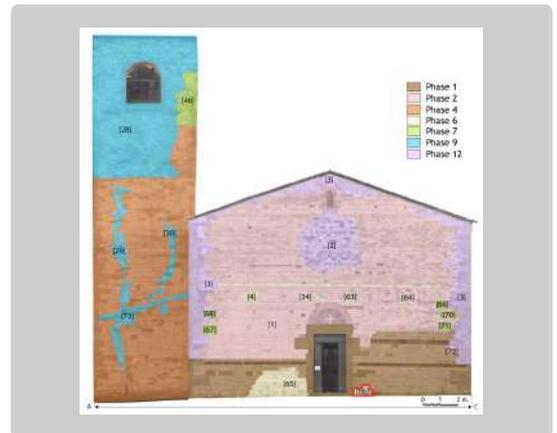
Id. OPUR 67

Localisation SantAgata, , , : Façade wall, load-bearing

Identity **Intervention partial** - ACoR : TCM2
Repaired part(s) : North, South ; Middle part

Hazard **Supposed collapse** (Partial overturning of the wall with rotations axis at the floor level)
Ancient origin : undetermined - Probability of the event undetermined

Other precisions Front wall of the church (MR1). External facing of the church. Use of large block of limestone very different to the TCM2 technique used in this part of the wall.
Probably linked to a repair of the corner quoins after the 1542 seismic event by the people of the village to repair the bending of the front wall. Indeed, the block is not decayed like the middle part of the wall.

Repair **Reconstruction**
Dimensions (cm) : Lenght 40, Width 20, Height 20, Thickness 0
Filling-in, Block : Stone, Mortar [Lime and sand]

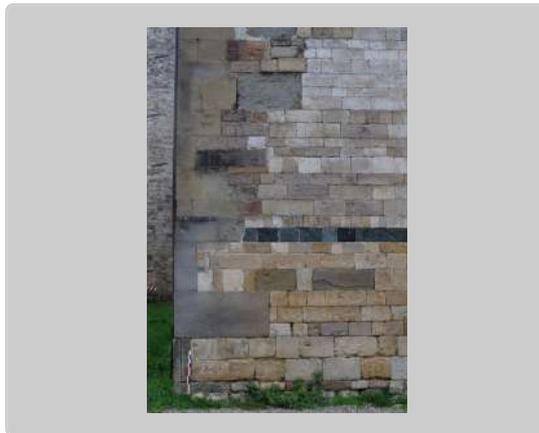
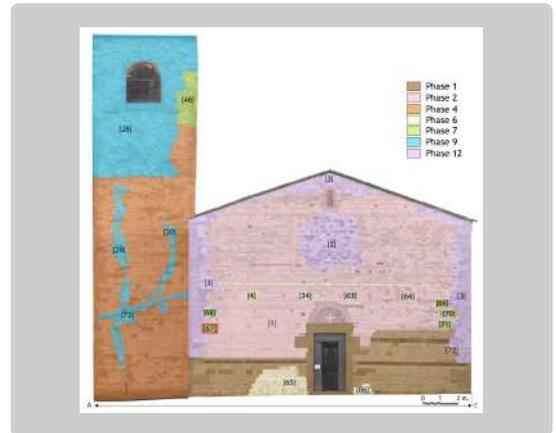
Id. OPUR 68

Localisation SantAgata, , , : Façade wall, load-bearing

Identity **Intervention partial** - ACoR : TCM2
Repaired part(s) : North, South ; Middle part

Hazard **Supposed collapse** (Partial overturning of the wall with rotations axis at the floor level)
Ancient origin : undetermined - Probability of the event undetermined

Other precisions Front wall of the church (MR1). External facing of the church. Use of large block of limestone very different to the TCM2 technique used in this part of the wall.
Probably linked to a repair of the corner quoins after the 1542 seismic event by the people of the village to repair the bending of the front wall. Indeed, the block is not decayed like the middle part of the wall.

Repair **Reconstruction**
Dimensions (cm) : Lenght 40, Width 20, Height 20, Thickness 0
Filling-in, Block : Stone, Mortar [Lime and sand]

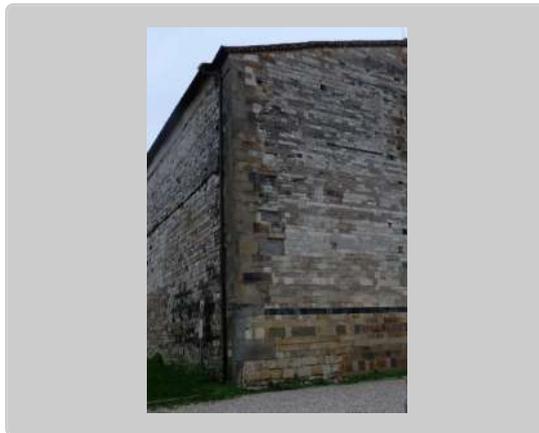
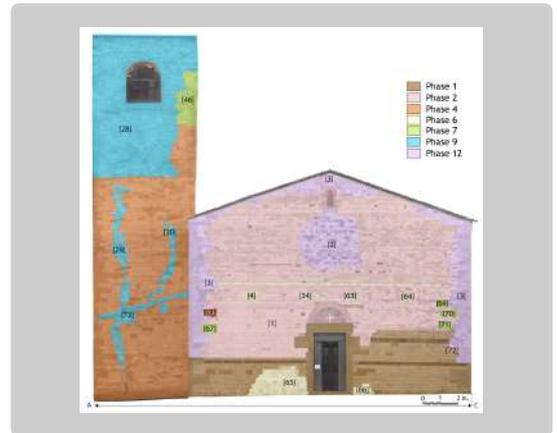
Id. OPUR 69

Localisation SantAgata, , , : Façade wall, load-bearing

Identity **Intervention partial** - ACoR : TCM2
Repaired part(s) : North, South ; Middle part

Hazard **Supposed collapse** (Partial overturning of the wall with rotations axis at the floor level)
Ancient origin : undetermined - Probability of the event undetermined

Other precisions Front wall of the church (MR1). External facing of the church. Use of large block of limestone very different to the TCM2 technique used in this part of the wall.
Probably linked to a repair of the corner quoins after the 1542 seismic event by the people of the village to repair the bending of the front wall. Indeed, the block is not decayed like the middle part of the wall.

Repair **Reconstruction**
Dimensions (cm) : Lenght 40, Width 20, Height 20, Thickness 0
Filling-in, Block : Stone, Mortar [Lime and sand]

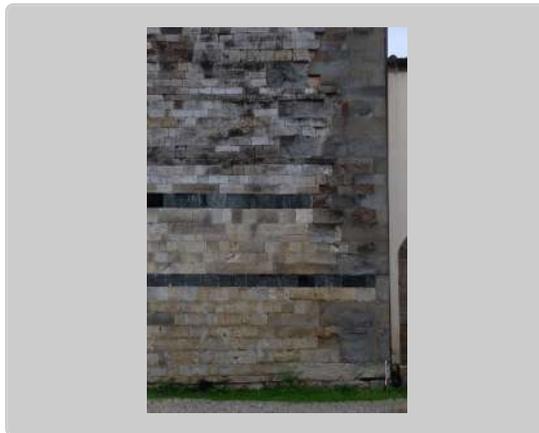
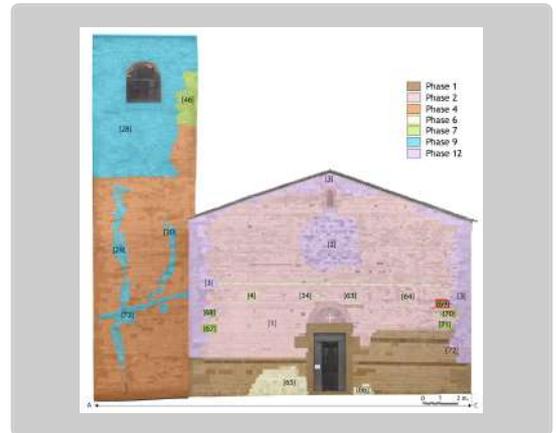
Id. OPUR 70

Localisation SantAgata, , , : Façade wall, load-bearing

Identity **Intervention partial** - ACoR : TCM2
Repaired part(s) : North, South ; Middle part

Repair **Reconstruction**
Dimensions (cm) : Lenght 40, Width 20, Height 20, Thickness 0
Filling-in, Block : Stone, Mortar [Lime and sand]
