Tracing the seismic history of Sant'Agata del Mugello (Italy, Tuscany) through a cross-disciplinary approach

Tracing the seismic history of Sant'Agata del Mugello (Italy, Tuscany) through a cross-disciplinary approach.

Keywords— historical seismicity, historical sources, building stratigraphy, architecture, structural analysis, damage mechanisms, Central Italy

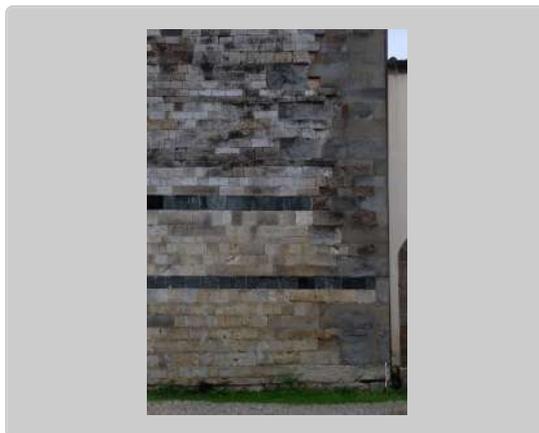
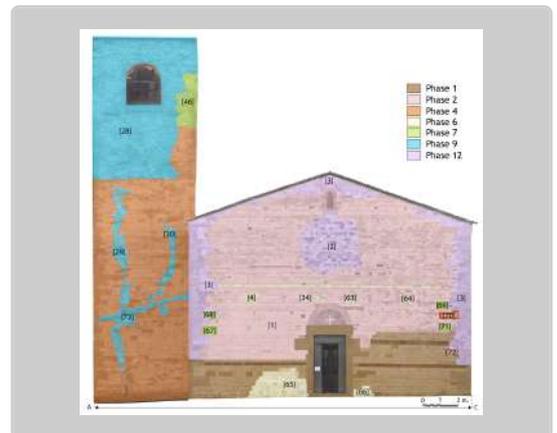
Id. OPUR 71

Localisation SantAgata, , , : Façade wall, load-bearing
